## ASBESTOS SURVEY

**San Joaquin Delta College**

**Shima Building**  
**Room 134 Courtyard**  
**(Kilns)**

**Stockton Environmental**  
*Report No. 013.11*  
*02/22/11*

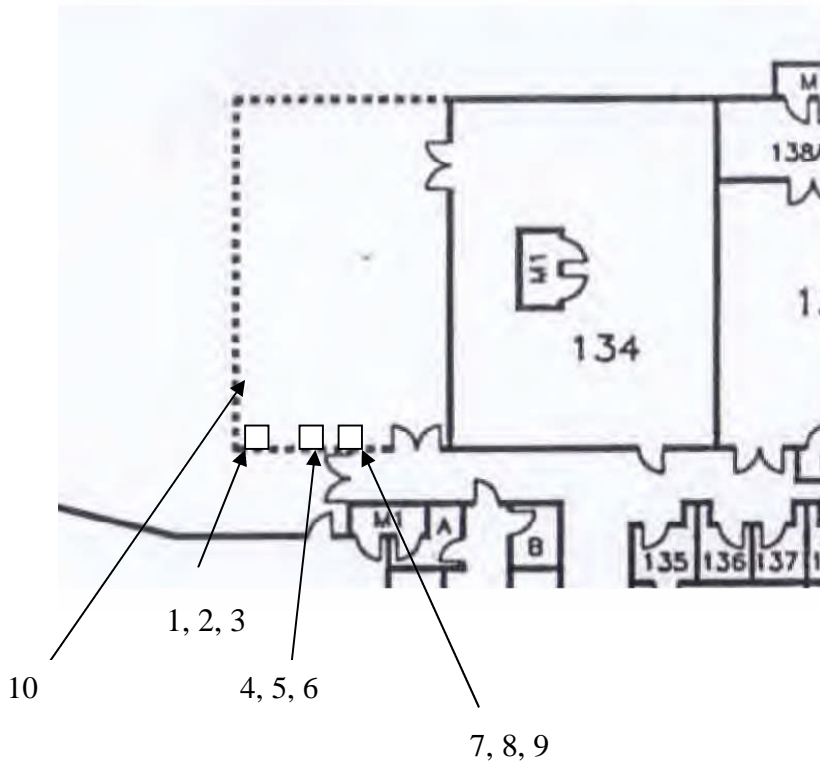
## Sample Location Map

**SE's** inspection services were conducted at the request of Ms. Stacy Pinola of San Joaquin Delta College. The inspection focused on the bricks associated with the three kilns located along the west wall of the courtyard.

The kilns are comprised of bricks of similar size but different colors.
